## Historic, archived document

Grays Harbor, Wn.

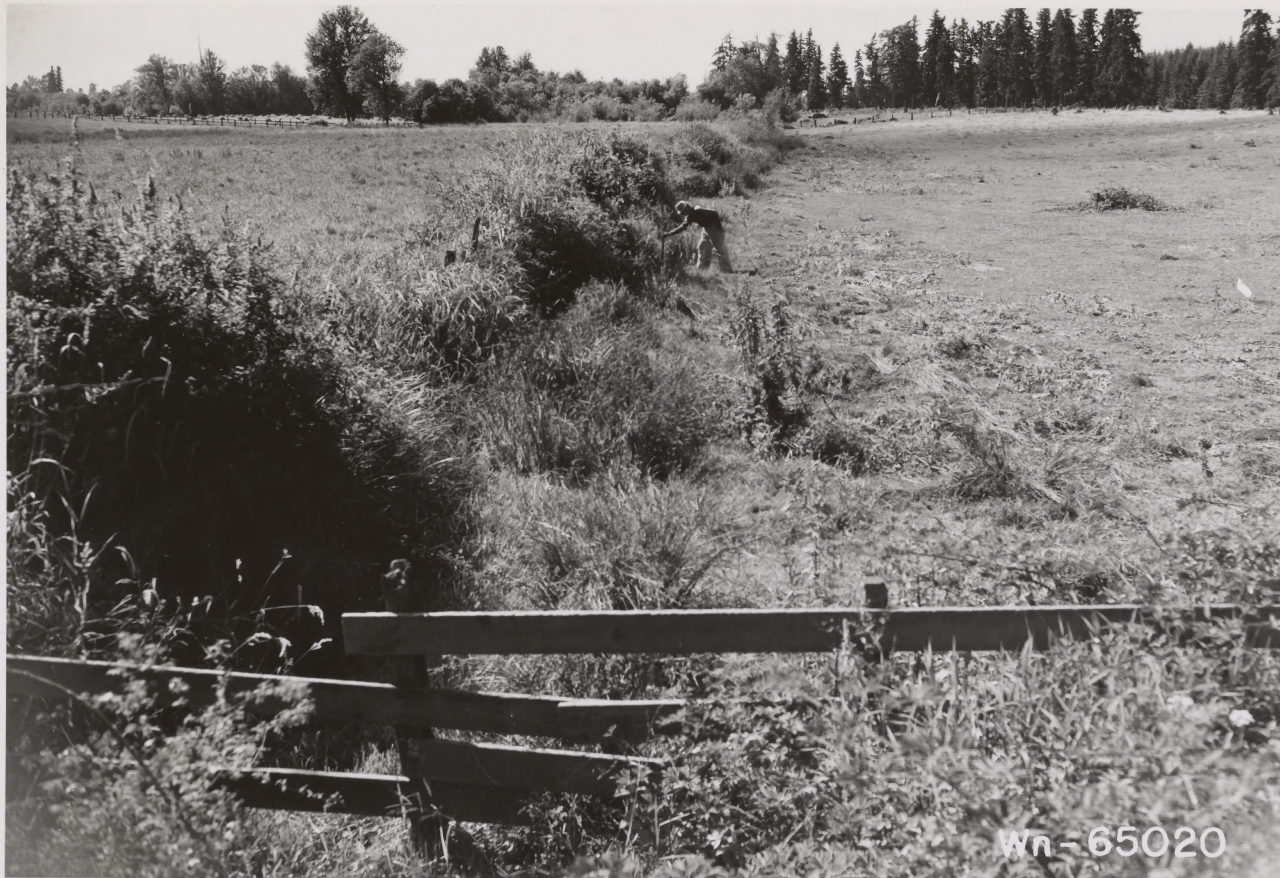
Wn-65020

Ditch to be blasted along the brush line.

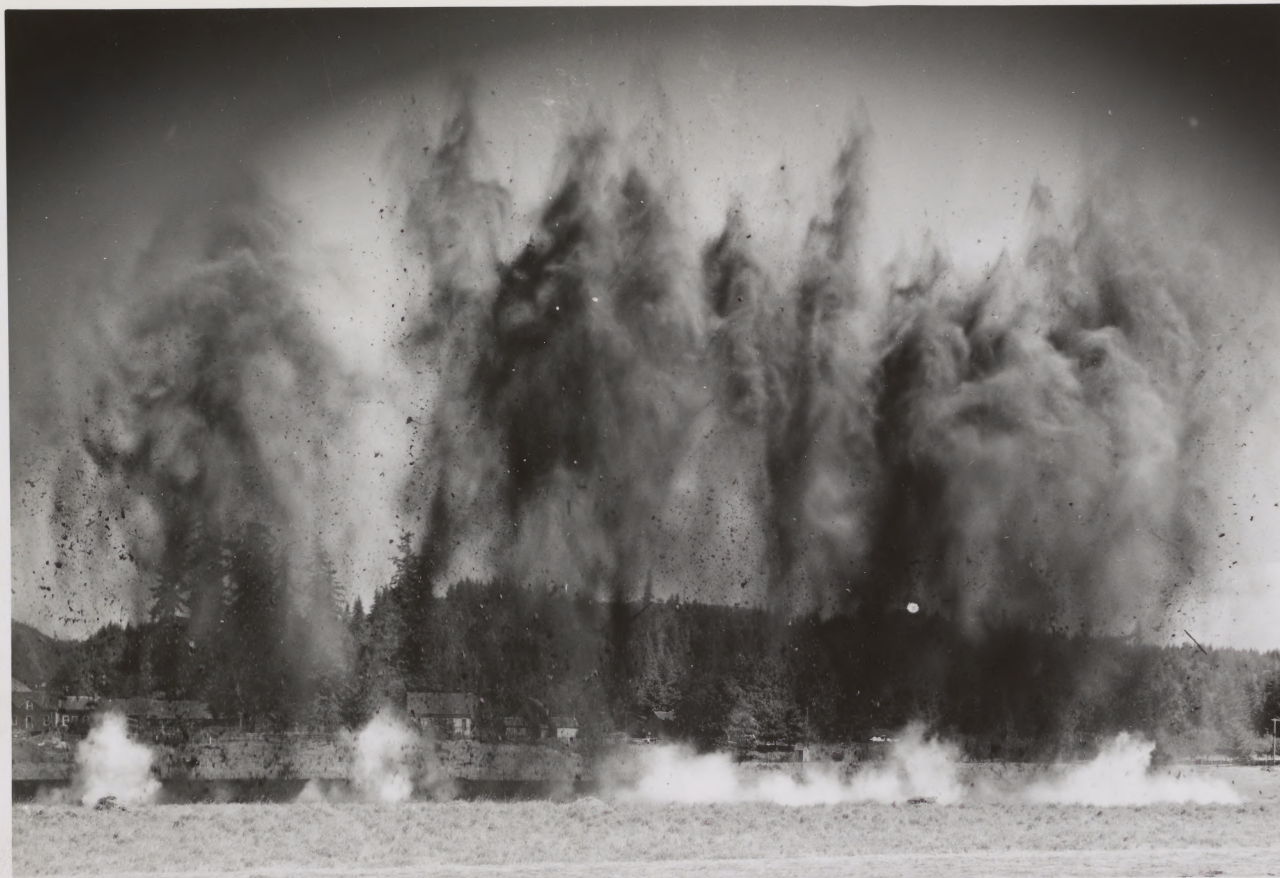
Wn-65021

Blasting ditch - Time 3 hrs - 4 persons (12 man hours) Ditch 375 ft -  
used 5 boxes 50%. The opening of this ditch will give a minimum of  
40 additional animal months of pasture on 20 acres drained by it. It  
will also serve a neighbor who helped in doing the work.

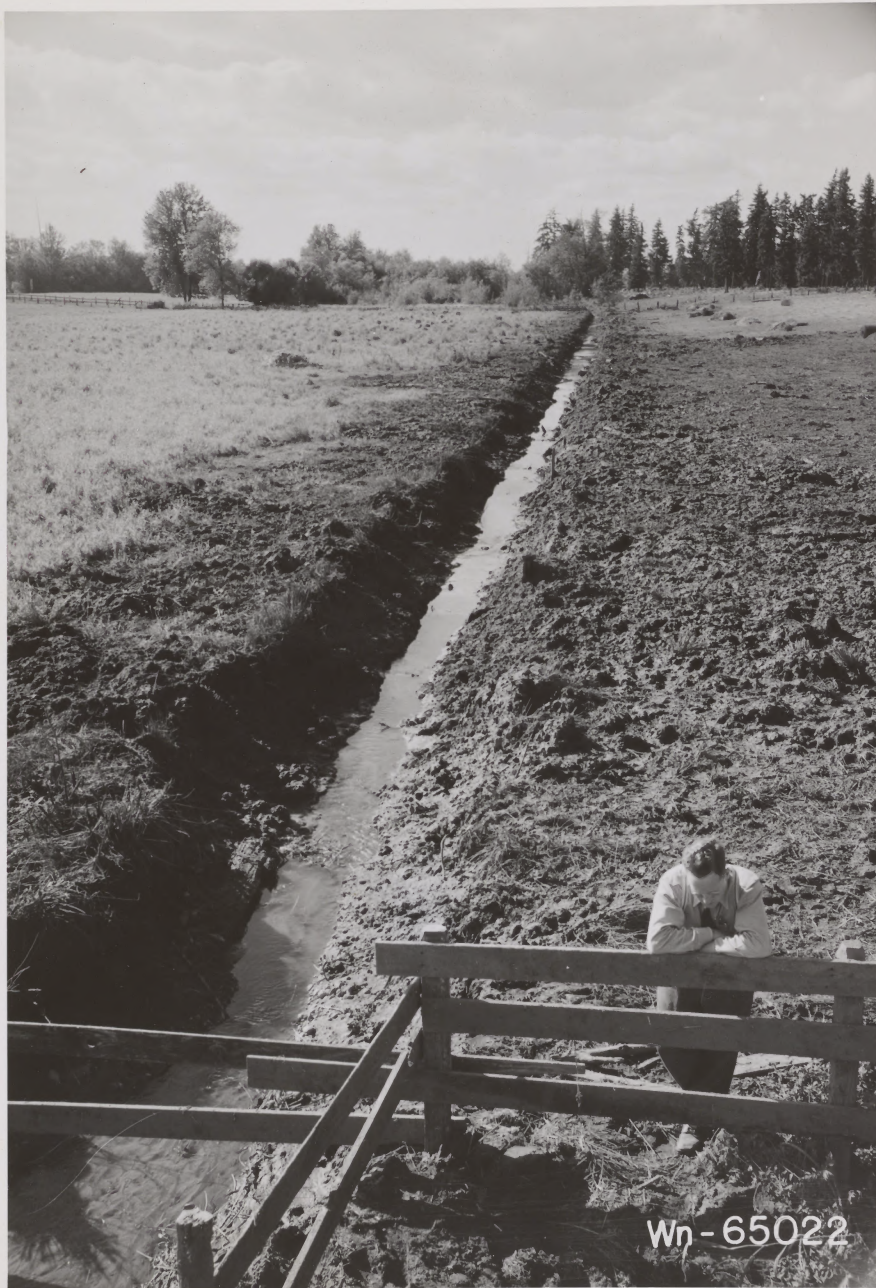
Wn-65022

View of ditch which has been dug  
with powder. Note small berms and  
even depth and uniform bank slope.

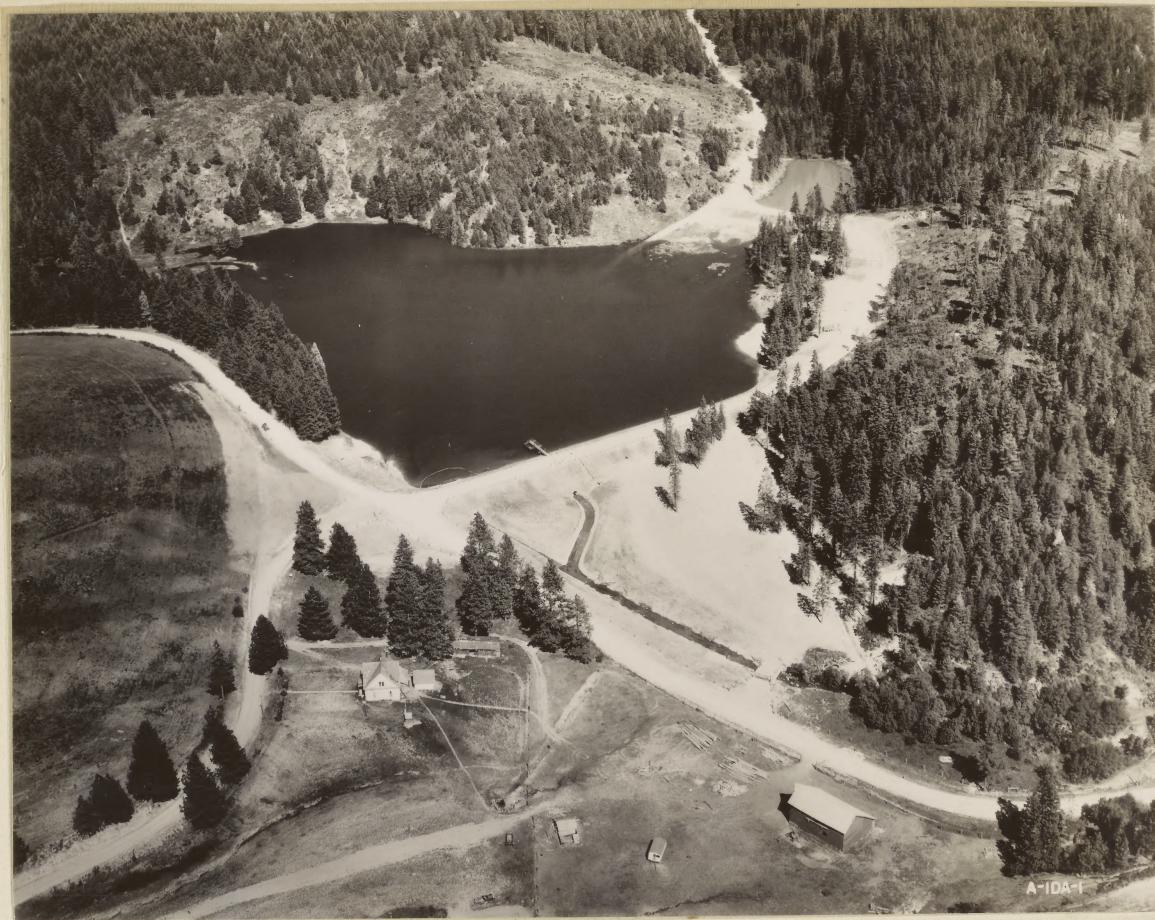
A-Ida-1

Robinson Park Dam northeast of Moscow, Idaho on Project area. Note de-silting dam in upper right background.

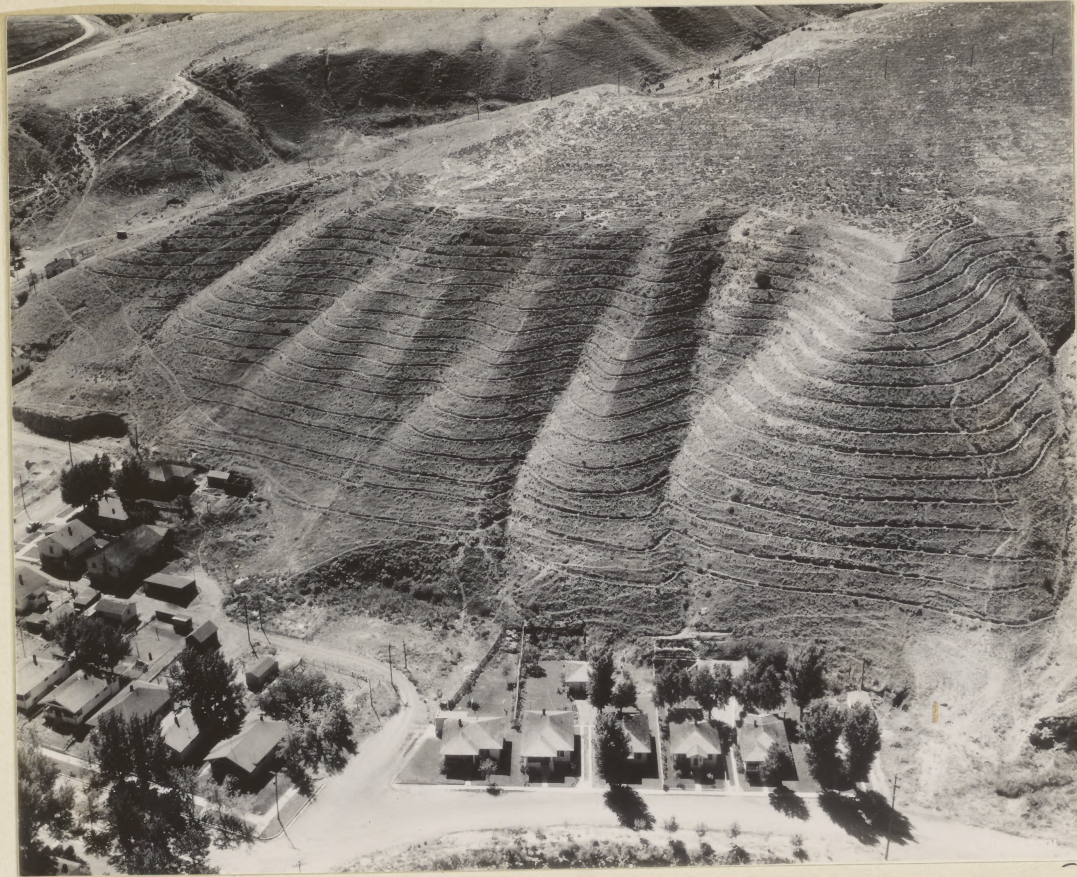
A-Ida-15,001

Low oblique of contour furrows on flood control program watershed  
surrounding city of Pocatello, Idaho.

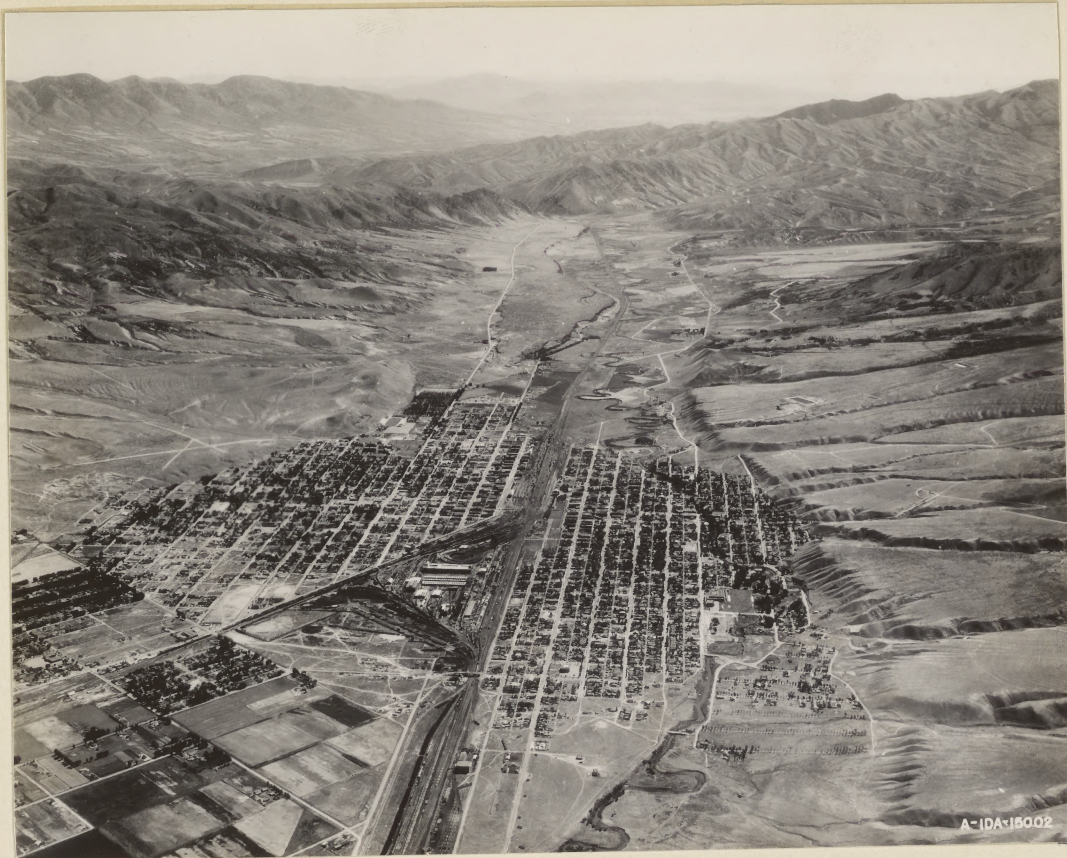
A-Ida-15,002

City of Pocatello, Idaho (area being protected by flood control program).

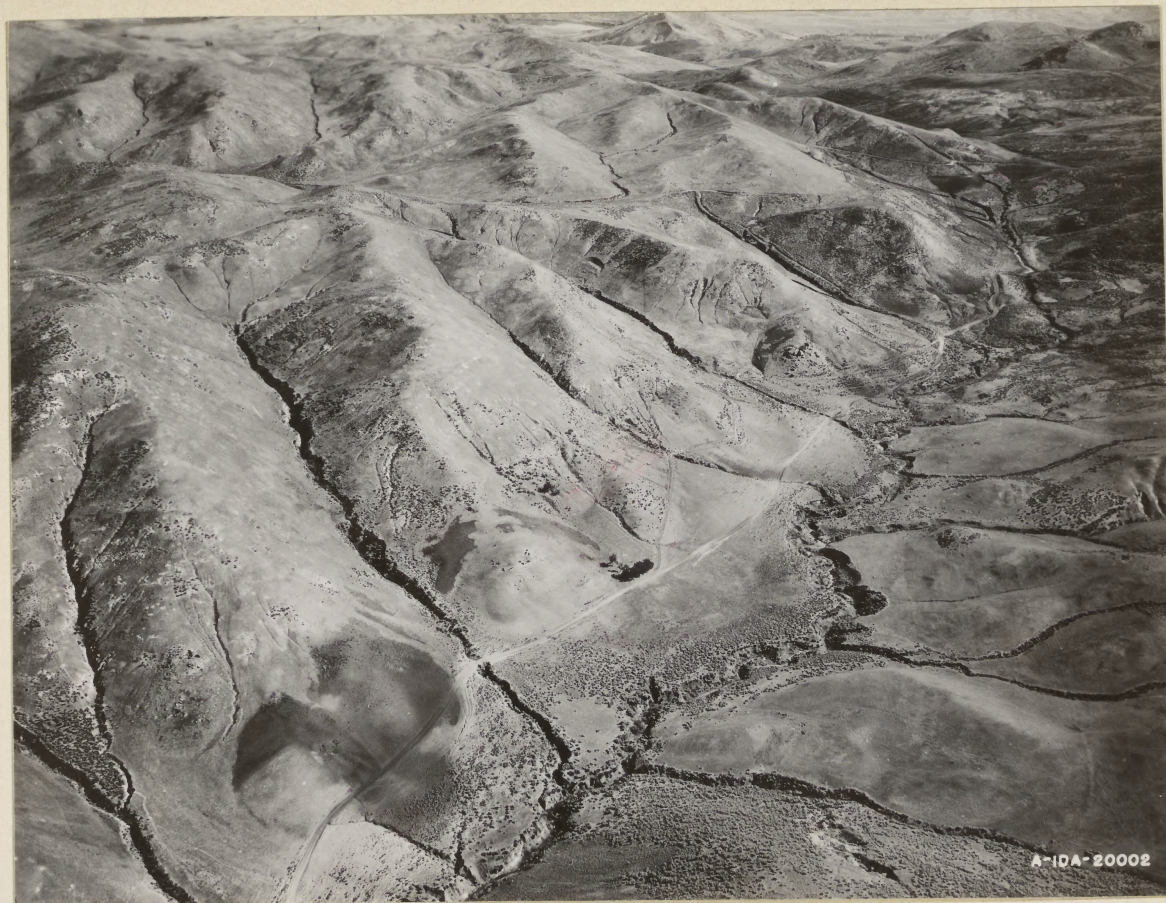
A-IDA-20,002.

Squaw Creek Project, Idaho.  
Range lands really "going". Much of area practically bare of  
adequate protective grass cover, result is the dissection that  
is evident in picture.

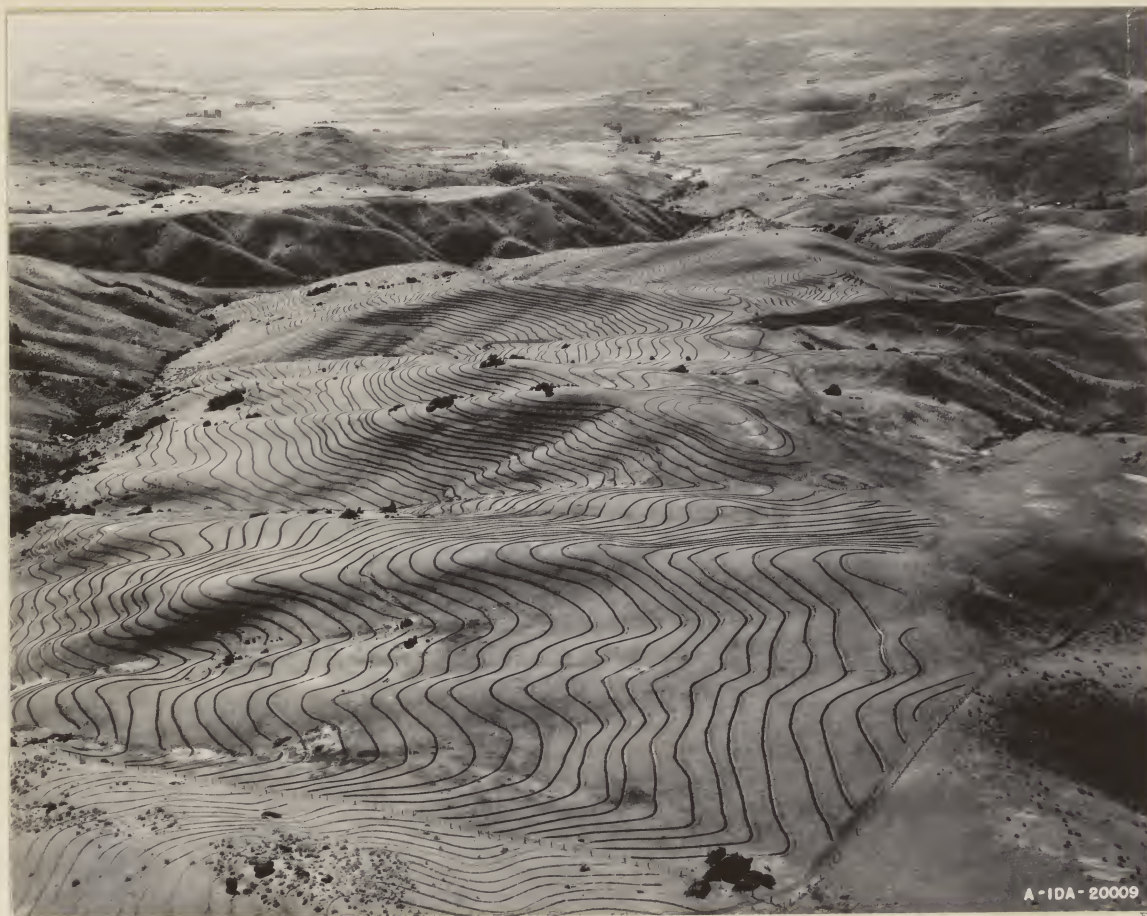
A-Ida-20,009

Contour furrows on range land southwest of Horseshoe Bend, Idaho.

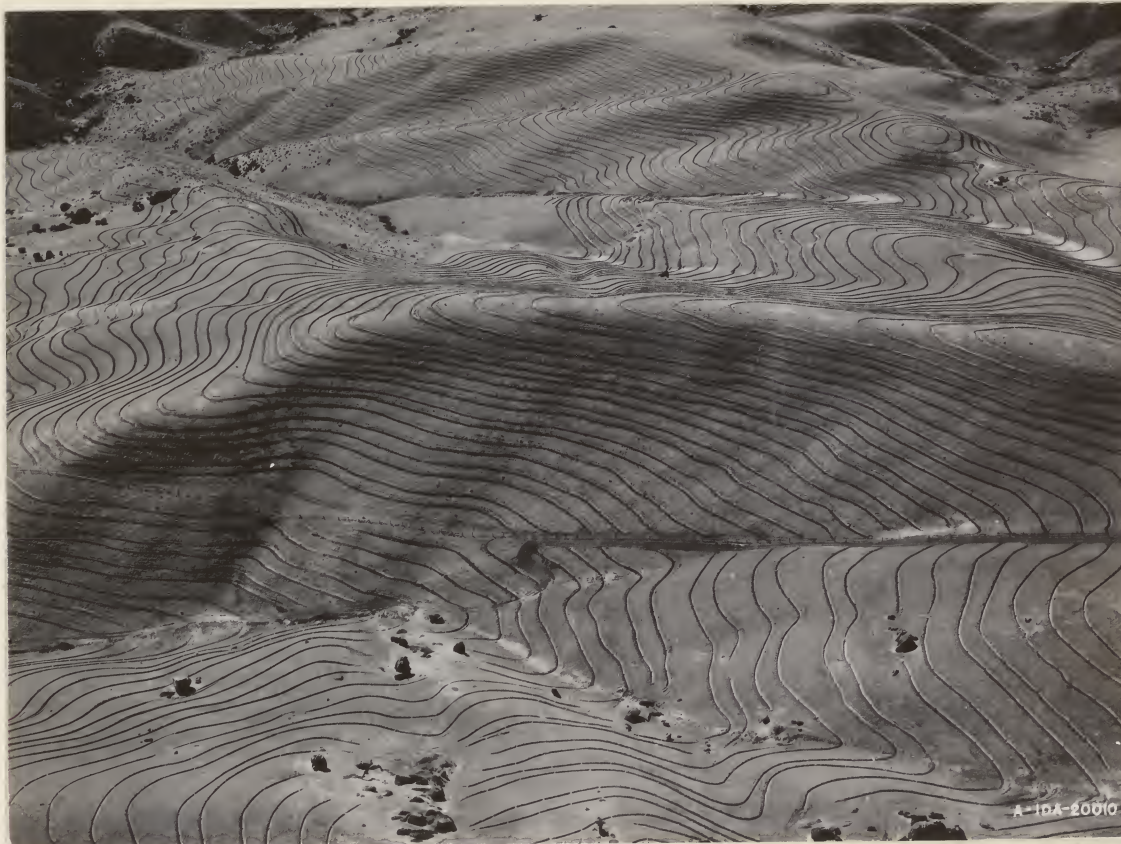
A-Ida-20010

Contour furrows constructed on overgrazed range land 15 miles south-east of Emmett, Gem County, Idaho, and two miles east of Sweet, Idaho. Land owned by Sweet Clover Land Company. These furrows serve to hold the moisture on these semi-arid lands and thus aid in the restabilization of a grazing area. Furrows were installed with a terracer and reversible plow, then finished by CCC hand labor under supervision of SCS.

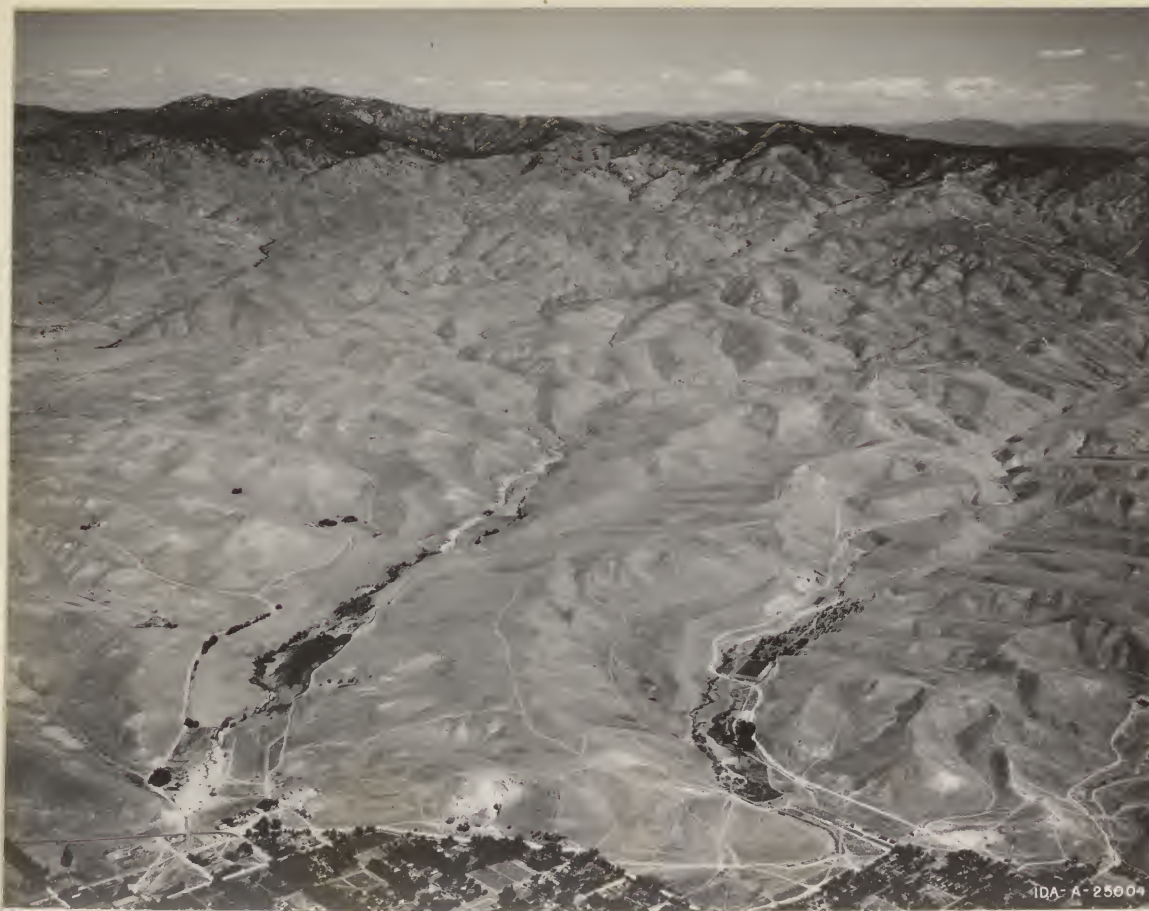
A-Ida-25,004

Photograph No. 3 of a series of overlapping obliques of the watershed east of the city of Boise, Idaho. These photographs were taken at the request of the Idaho State Coordinator, SCS, for distribution to field parties in order that a preliminary survey of a particular area could be made before the parties actually went into the field.

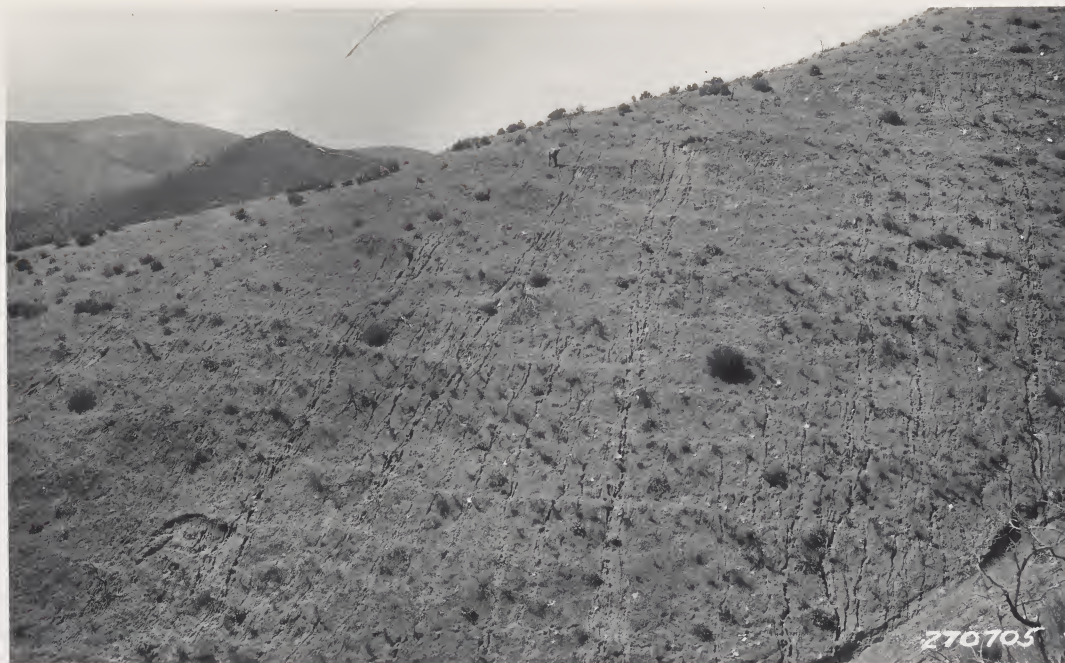
270705

Although under Federal management for 30 years, too many livestock have destroyed most of the original plant cover and induced serious erosion conditions. Boise National Forest, Idaho. Photo by F. G. Renner.

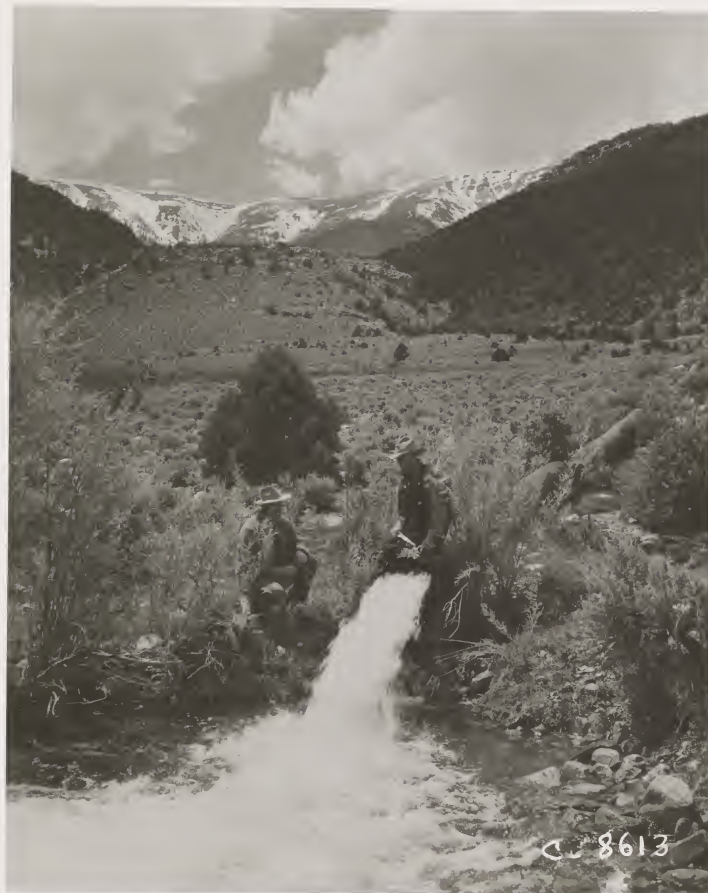
C-8613

White Pine Soil Conservation District, East-central Nevada  
12" metal pipe line 1 mile long. W. S. Hacket ranch.

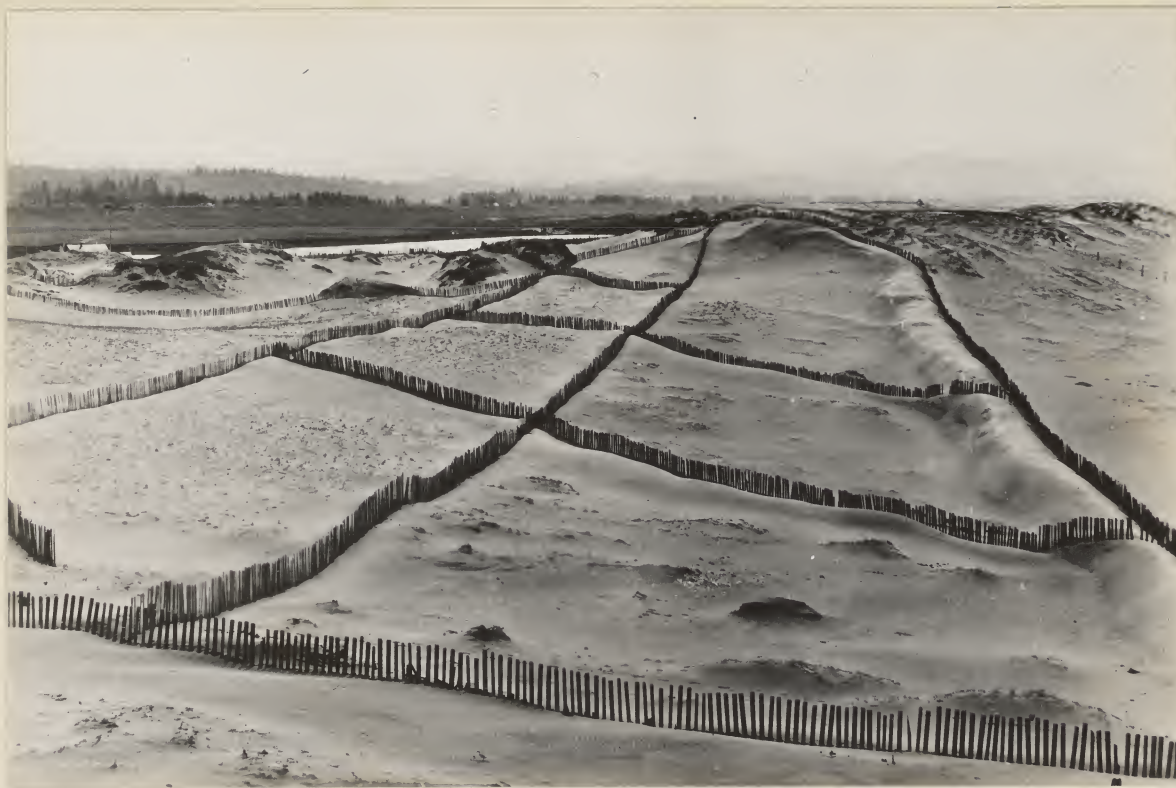
Ore-35,007. Oregon.  
EROSION CONTROL - Wind Control.

Photograph showing a catch fence on the right and sand-stilling fences to preserve partially vegetated area. The catch fence shown here is also serving to build up a wind gap in the second dune.

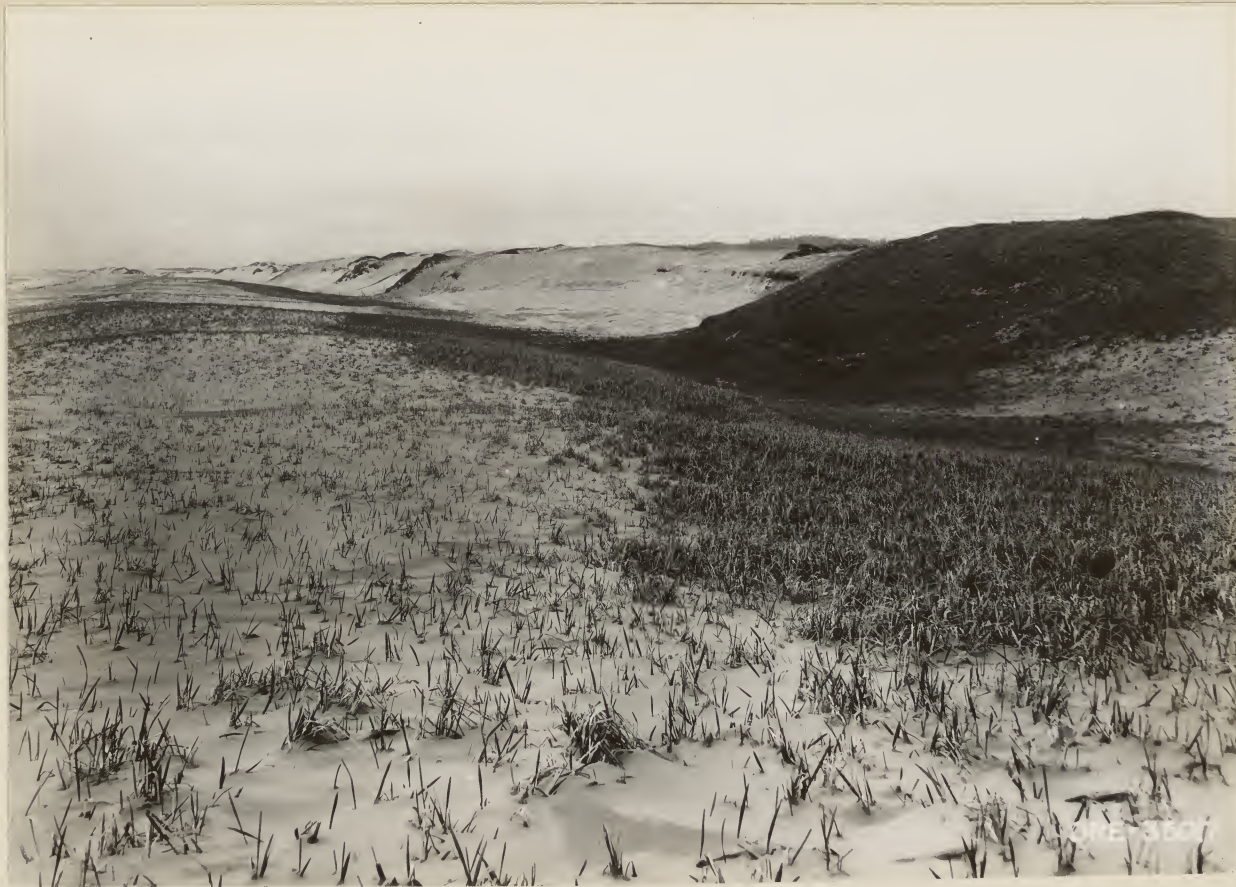
Ore-35,017. Oregon.  
EROSION - Wind.

Looking north along a newly forming fore dune on the Emily Waterhouse place. The line of sand encroachment in the Sea Lyme grass can be seen. In the fall the top of the dune was as thickly covered as the back slope. Winds during the past winter raised the dune from six to twelve inches. This new fore dune has already attained sufficient height to afford protection to the back areas during ordinary years. April 2, 1936.

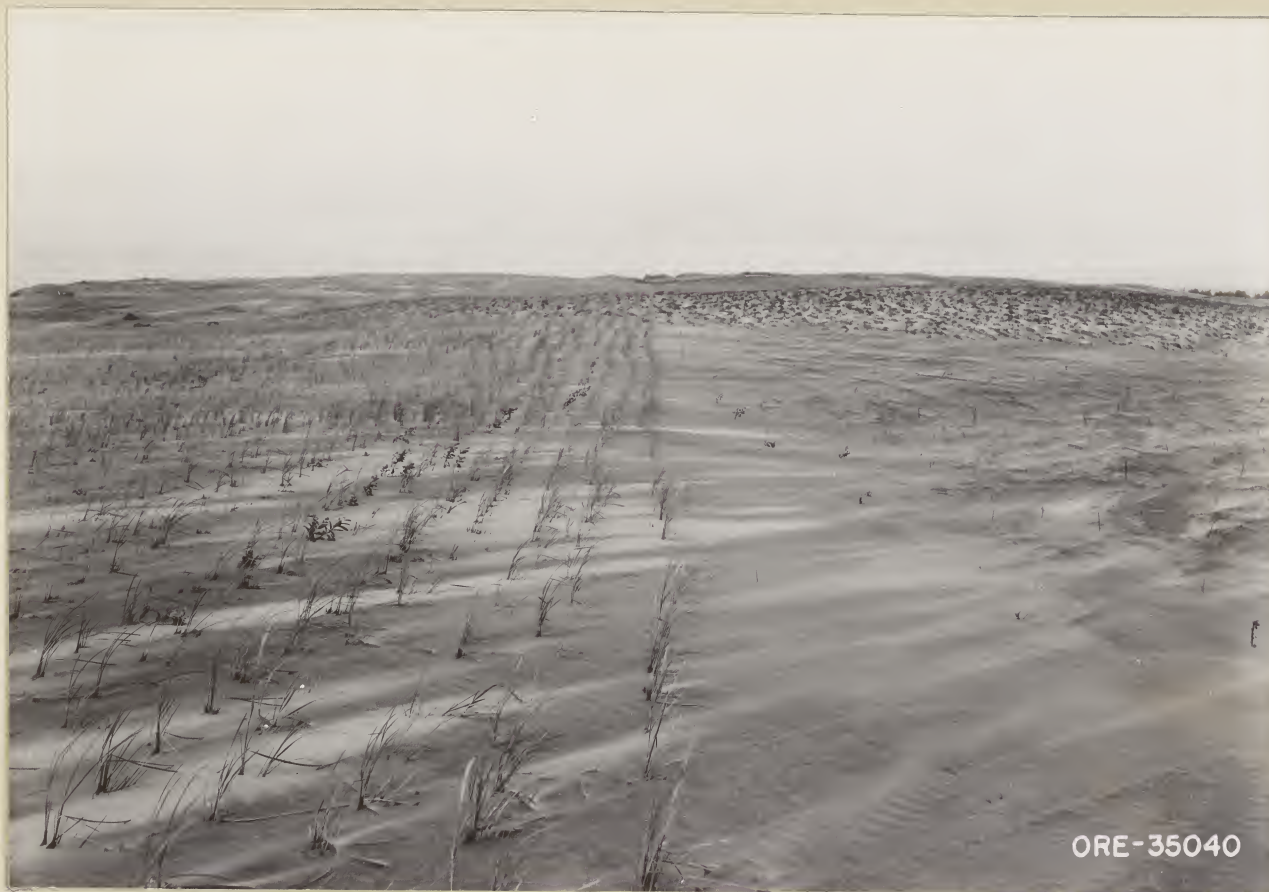
Ore-35,040

A comparison of Holland grass and willow plantings. Note sand building about Holland grass.

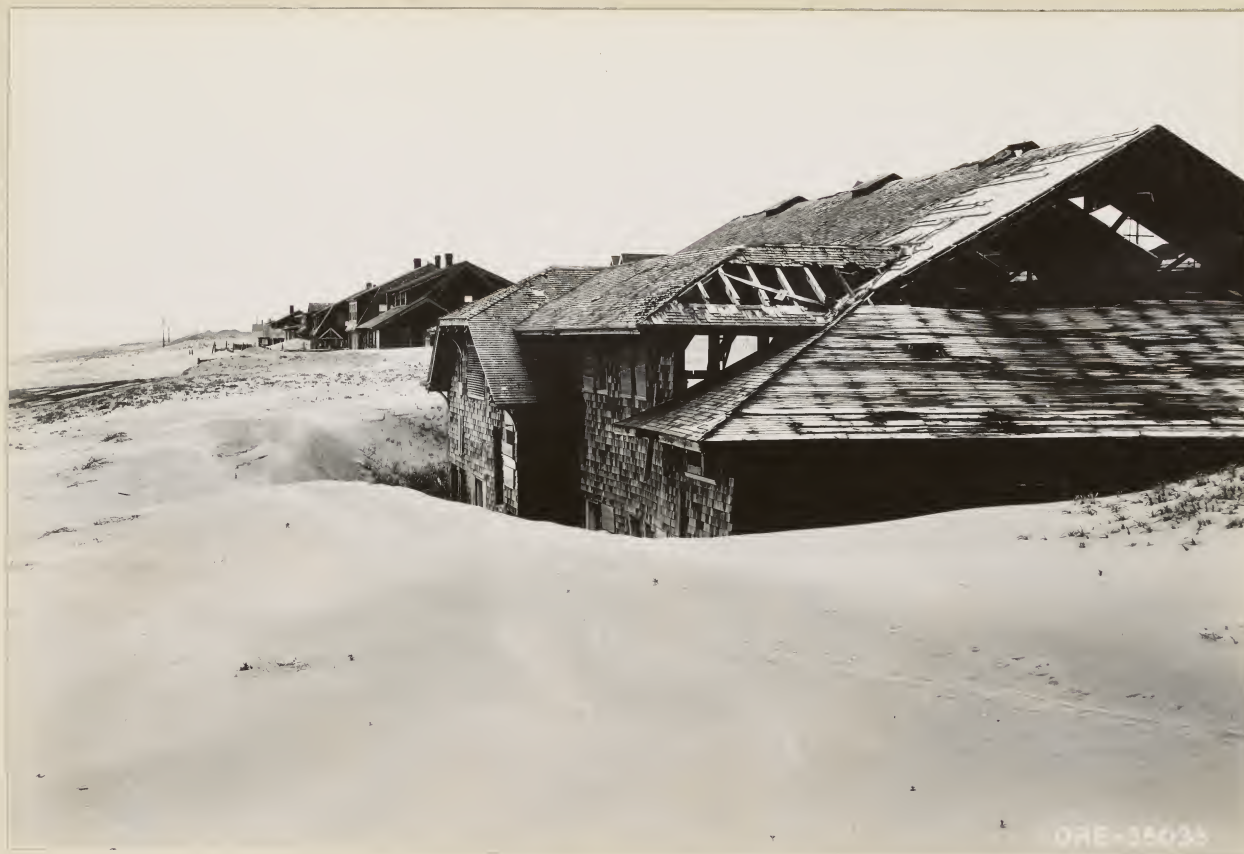
Ore-35,035. Oregon.  
EROSION - Wind.

Sand movement from unprotected beach area encroaching upon summer cottages and rapidly destroying valuable property. Clatsop County. 6/15/36.

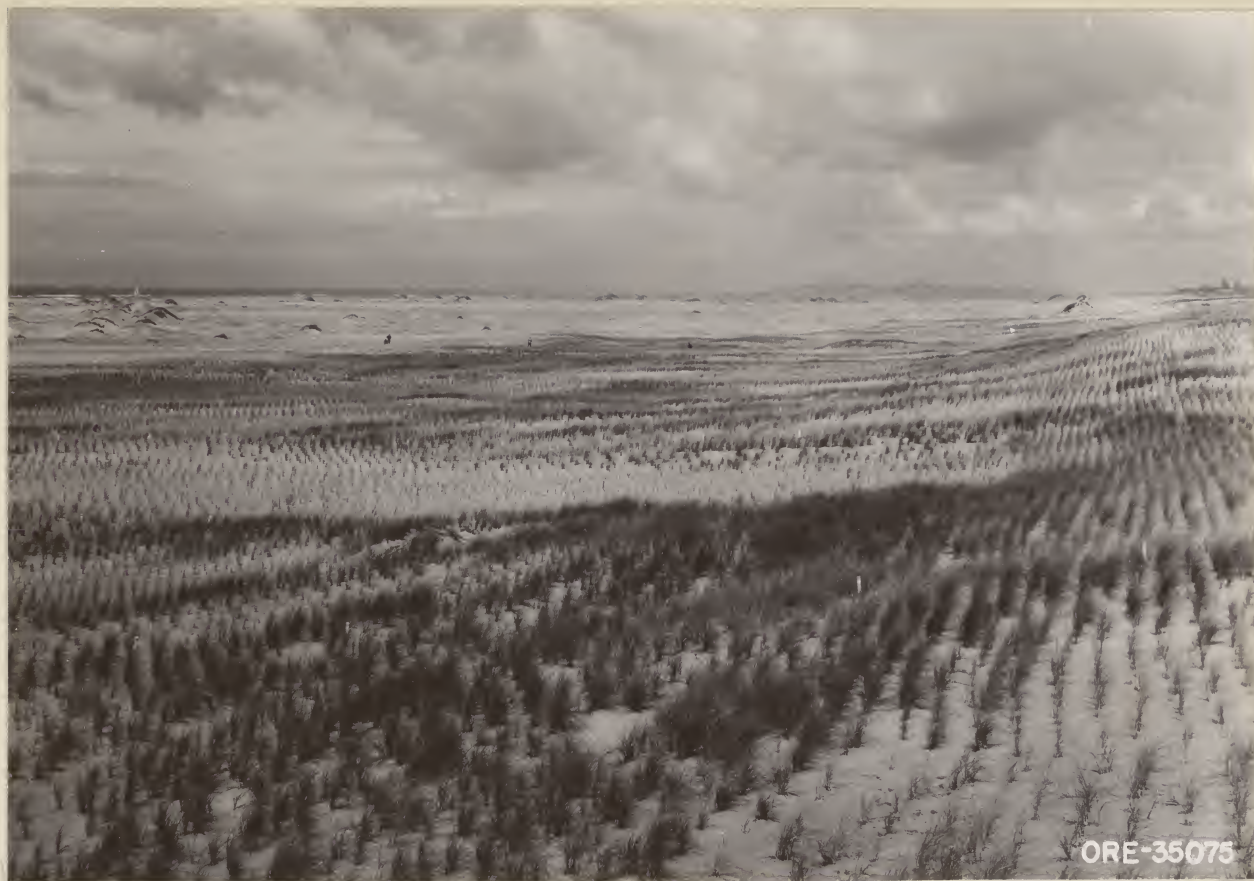
Ore-35,075

A view of the observational grass nursery on bare sand, Astoria Nursery Unit. Date and rate of planting, spacing trials and effect of fertilizers are being tested to determine management for production of sand-stilling grasses. Two hundred eighty one-fortieth-acre field plantings are shown. Differences in responses to management and treatment can plainly be seen.

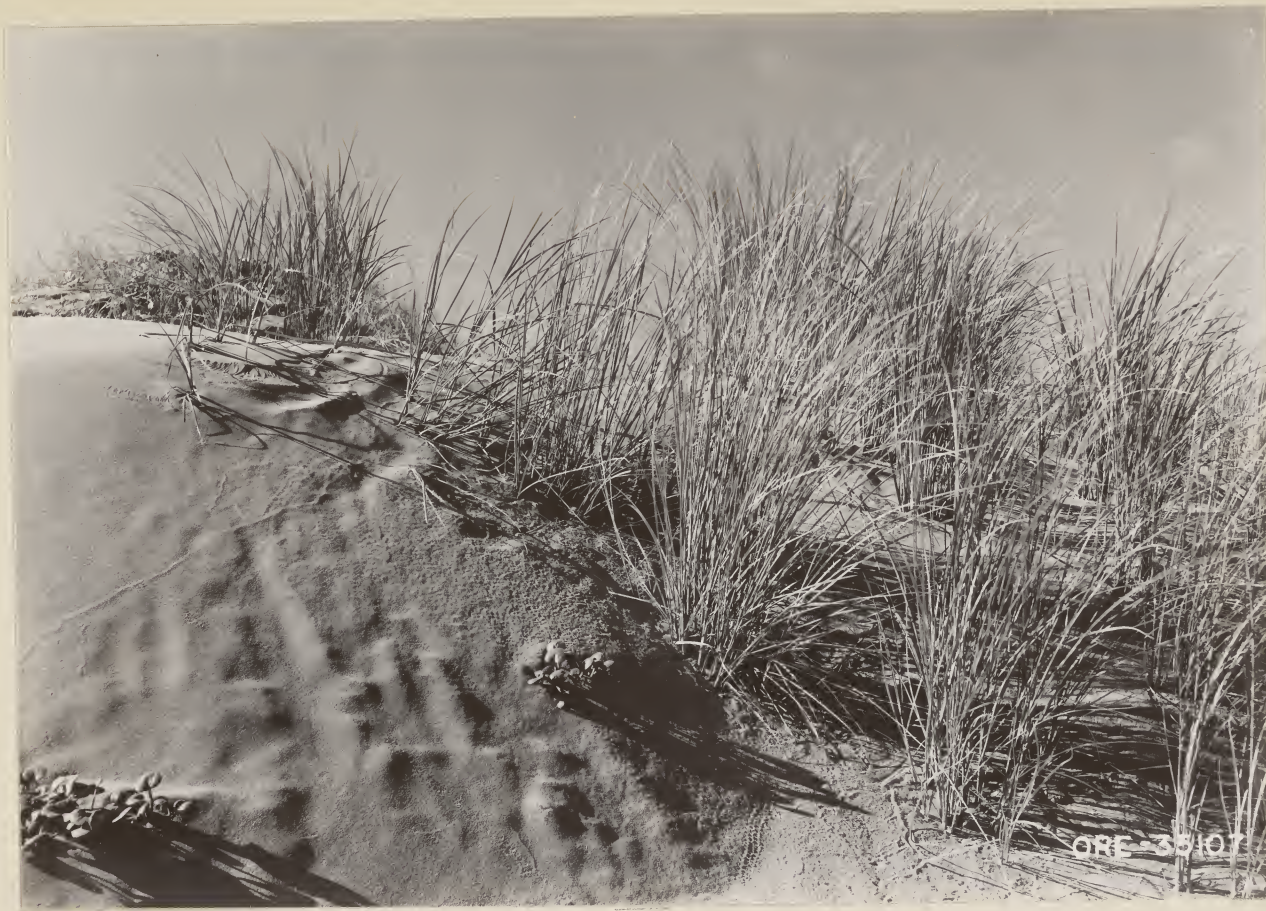
Ore-35,107

Two-year old plantings of Holland grass (Ammophila arenaria) on land owned by State of Oregon Military Department. Note catchment of sand drift and thrift of the Holland grass as well as beginning of invasion of sand verbena (Abronia latifolia spp.)

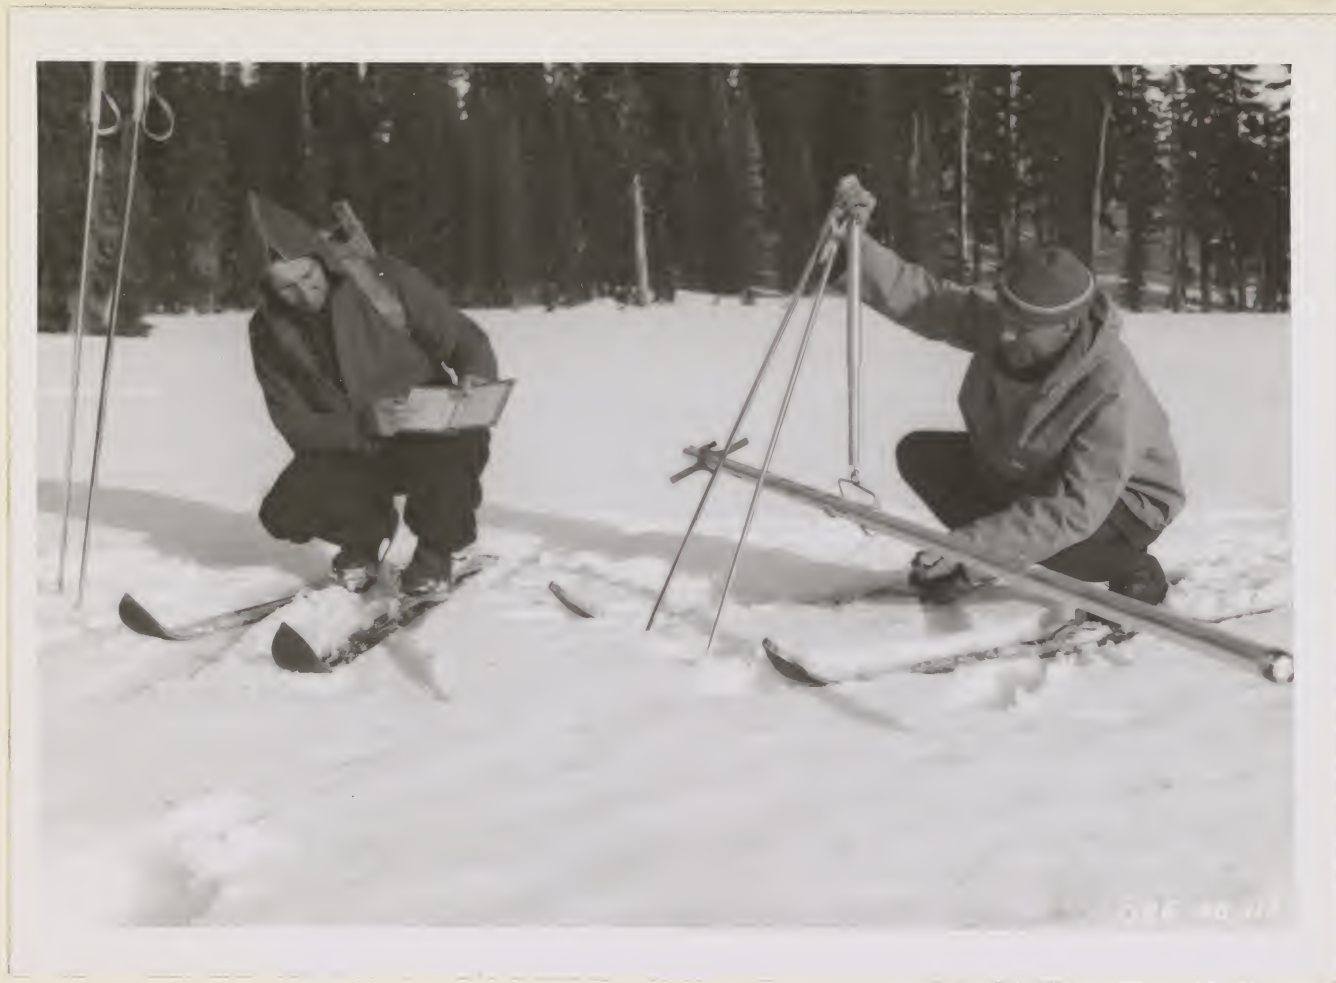
Ore-40112

G. F. Sturdevant, left, records the water content on the Seven Lakes snow course, as R. W. Childreth, right reads the figures from the scale.

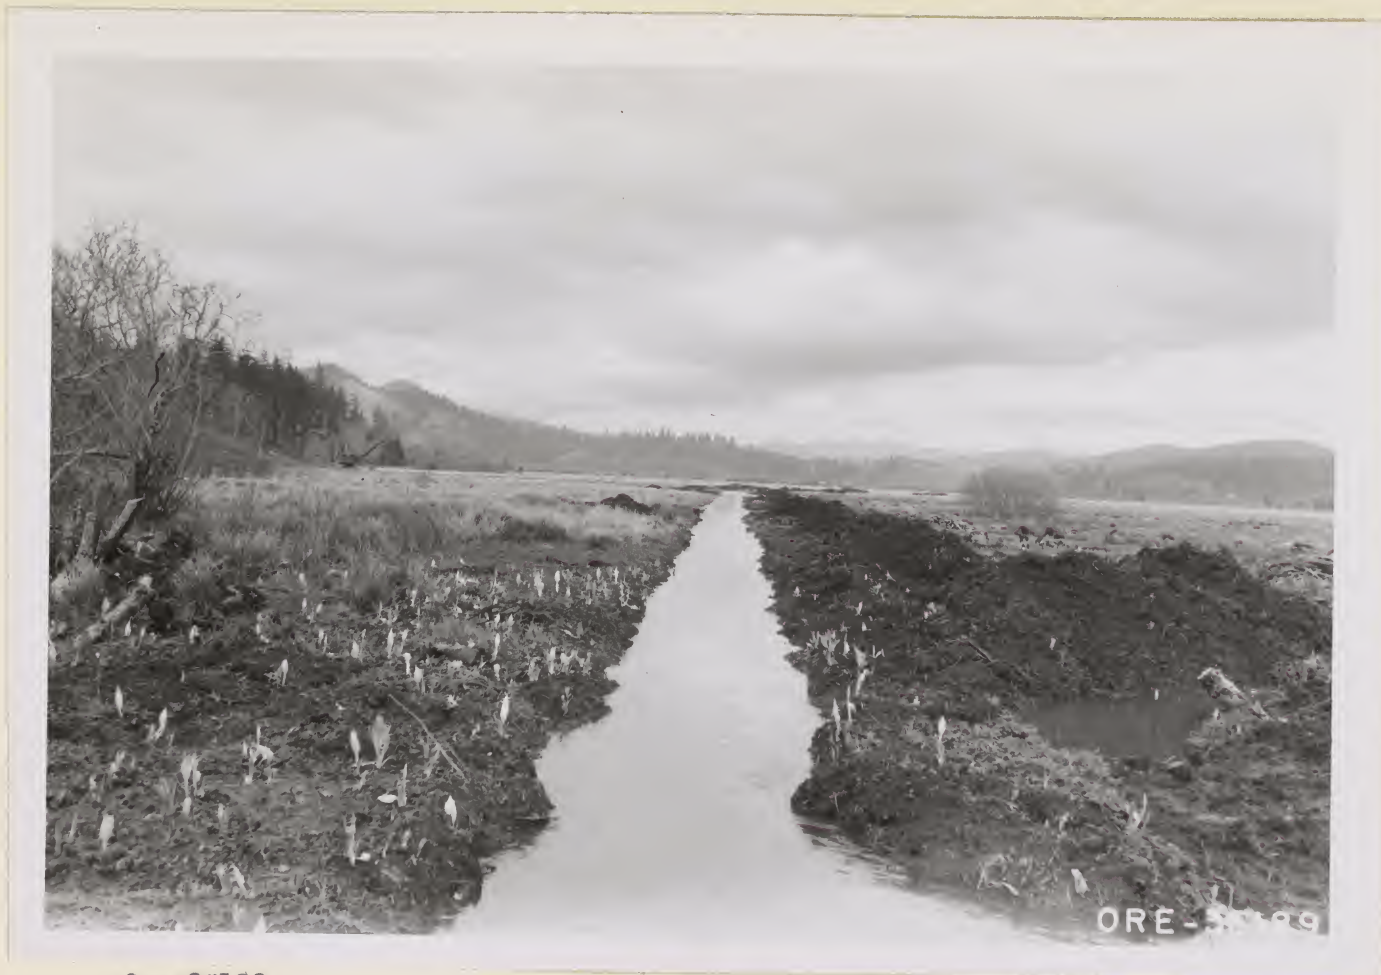
Ore-35189

This ditch was constructed to improve the drainage along the lower Little Nestucca river. The soil is largely Clatsop silty clay loam, with occasional patches of peat. It is in Land Capability III due to the difficulty of maintaining adequate drainage. Completion of this job will require removal of brush and tussocks and seeding to improved pasture grasses.

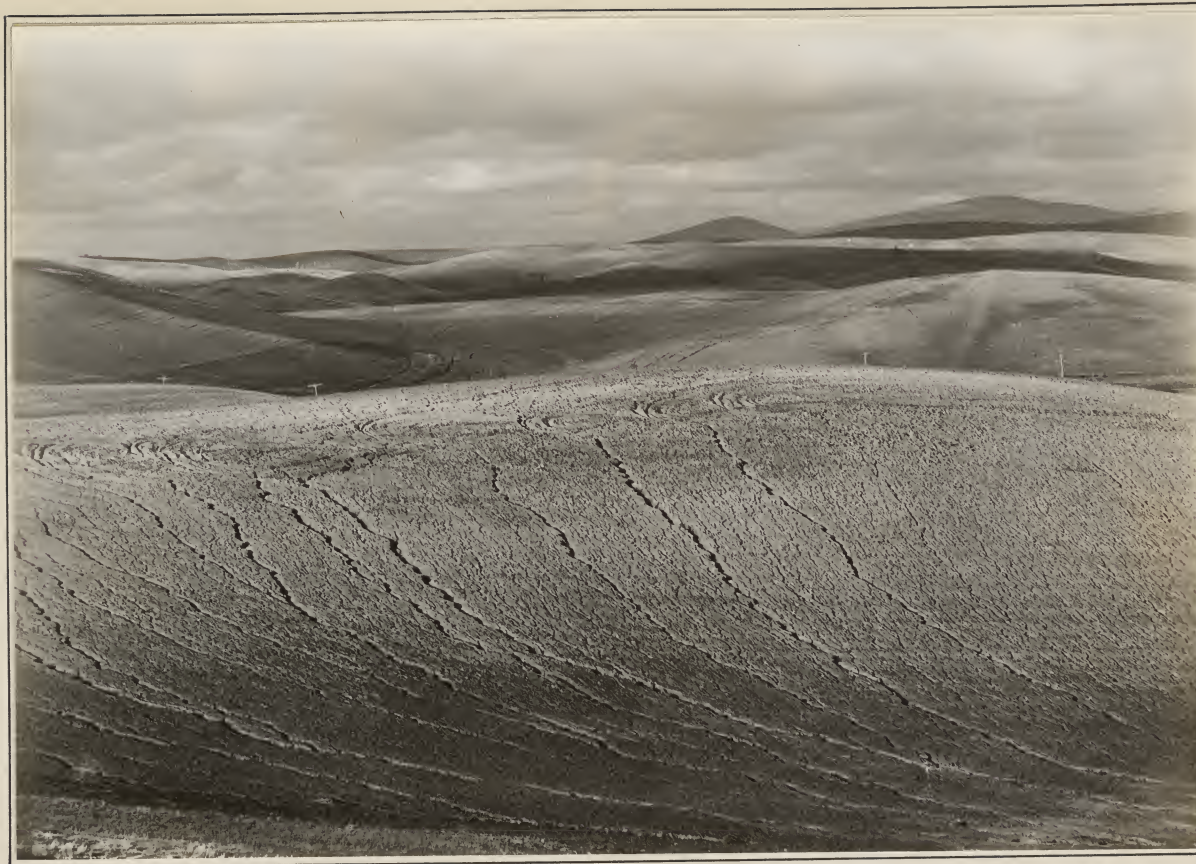
6-44 - Pullman, Washington  
— EROSION - Sheet

Sheet erosion on Palouse silt loam. This land lost at least 50 tons of soil to the acre. It was summer-fallowed in 1933 and left unprotected against the forces of erosion during the winter. The clay hilltop absorbed little water and a heavy run-off was responsible for the severe erosion on the slope. C. J. Bower farm, near Moscow, Idaho. January 30, 1934
